WANAQUE GRADIENT  
CORROSION CONTROL  
REVIEW – INITIAL DRAFT

**City of Newark**  
Lead and Copper Rule Compliance Study  
Wanaque Gradient

City of Newark Department of  
Water and Sewer Utilities

February 1, 2019

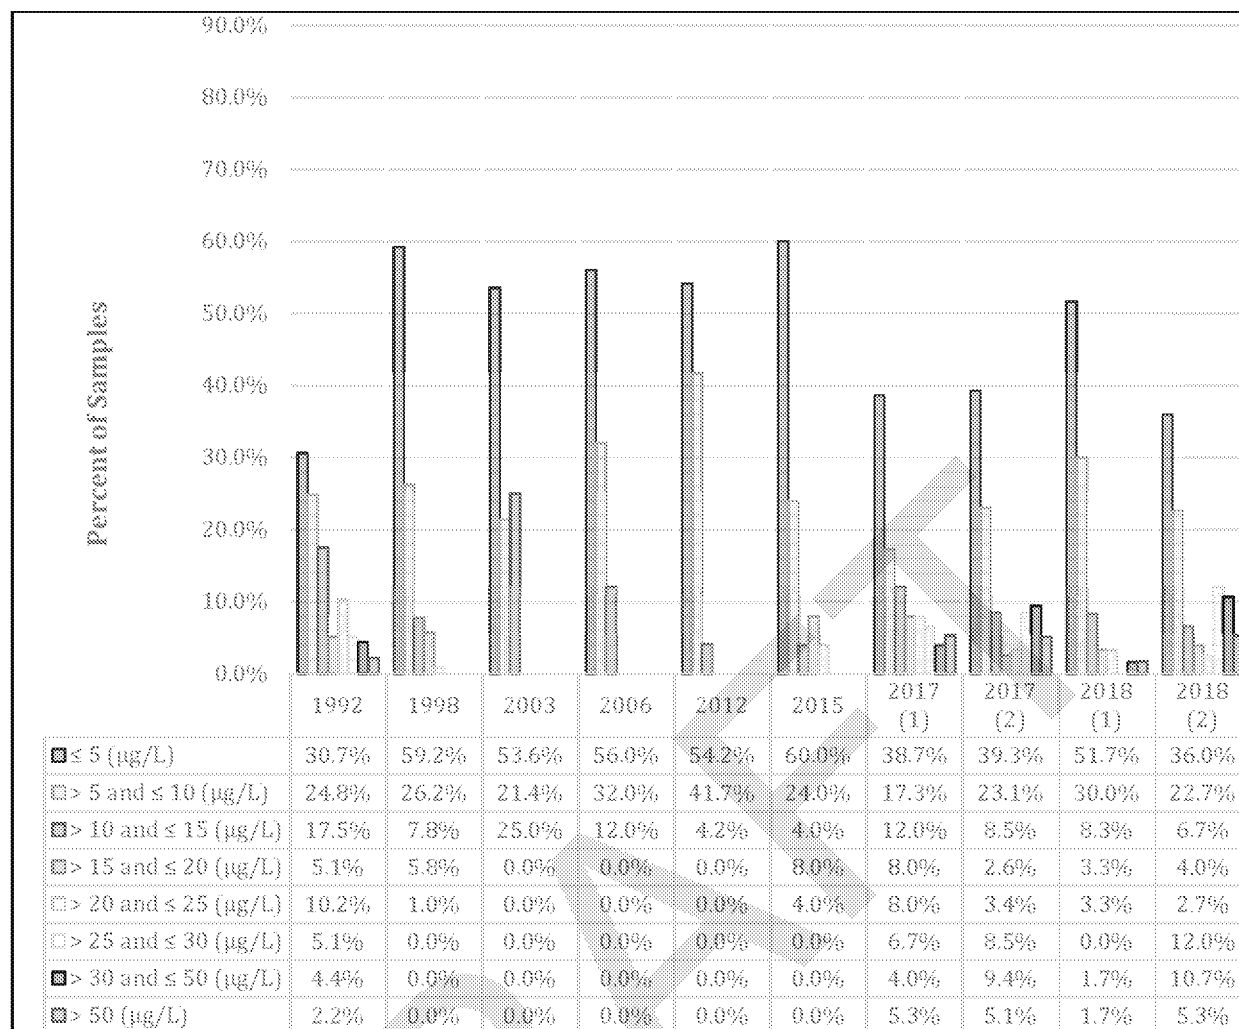
Figure 2-1 – Pequannock Service Area – Lead Sampling Data Percentage Frequency Distribution

**Figure 2-1** provides an overview of the lead sampling compliance data from the ten (10) sampling events for the Pequannock service area for the different “bins” from less than 5 µg/L to greater than 50 µg/L. **Table 2-1** provides a summary of some statistical parameters based on the lead sampling compliance data, and **Table 2-2** provides an interpretation of the findings of the frequency distribution analysis for the Pequannock service area.

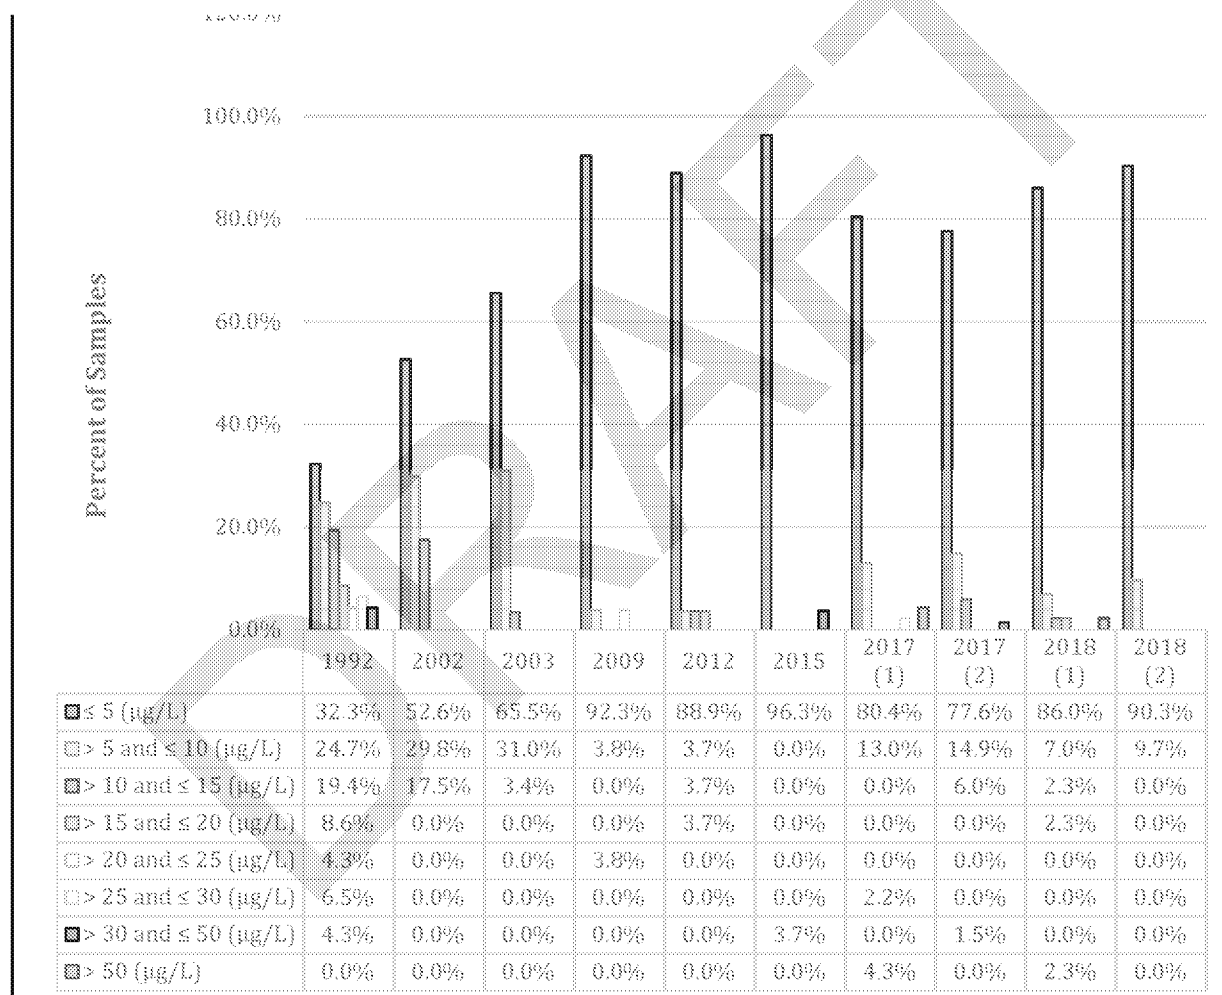
**Figure 2-2 – Wanaque Service Area – Lead Sampling Data Percentage Frequency Distribution**

**Figure 2-2** provides an overview of the lead sampling compliance data from the ten (10) sampling events for the Wanaque service area for the different “bins” from less than 5 µg/L to greater than 50 µg/L. **Table 2-3** provides a summary of some statistical parameters based on the lead sampling compliance data, and **Table 2-4** provides an interpretation of the findings of the frequency distribution analysis for the Wanaque service area.

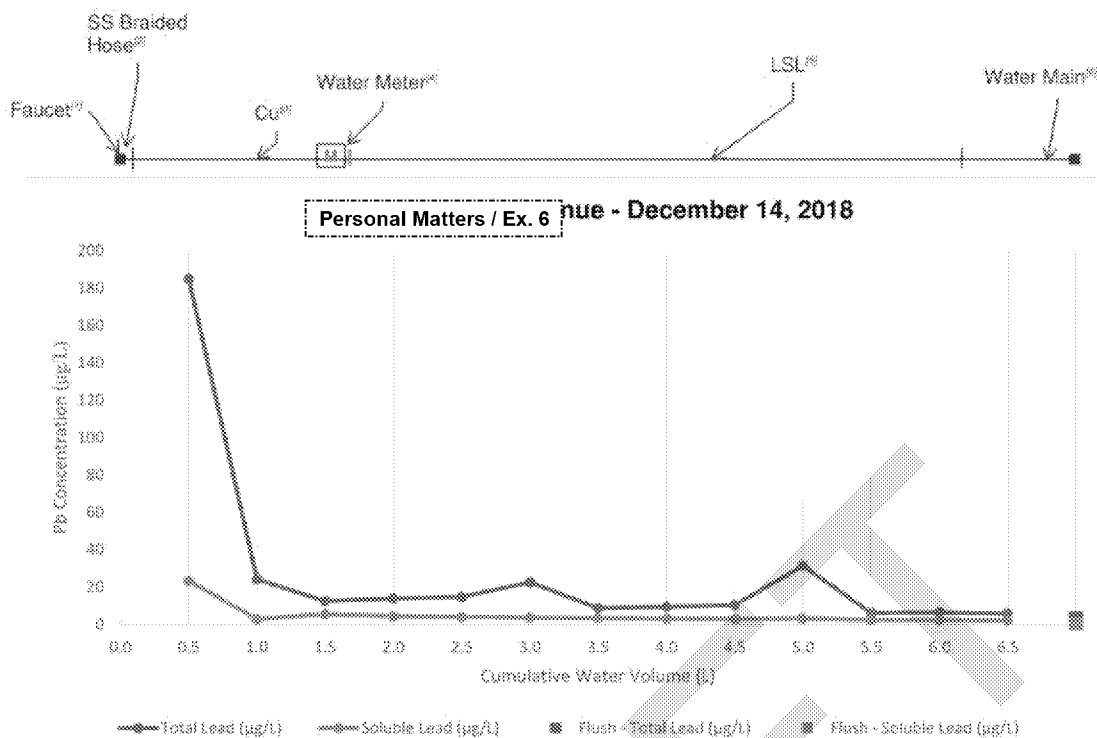
**Figure 4-2 – Personal Matters / Ex. 6 Lead Profile – December 14, 2018**

- The highest lead levels at this address were found in the interior plumbing components, including the faucet hosing and piping directly connected to the faucet. For the first sequential sampling, before the LSLR, soluble lead peaked at 23.4 µg/L and total lead at 185 µg/L in the first sample (on the faucet hosing and interior plumbing components). For the second sequential sampling (post LSLR), soluble lead peaked at 19.8 µg/L in the 12<sup>th</sup> sample and the total lead peaked at 108 µg/L in the first sample.

- Significant particulate lead was found at this address in the first draw samples in both sequential sampling events. For the first sequential sampling, the aerator was removed on site prior to collecting samples but after flushing and stagnation. For the second sequential sampling, the aerator was removed prior to flushing and the stagnation period and remained off until sampling was completed.

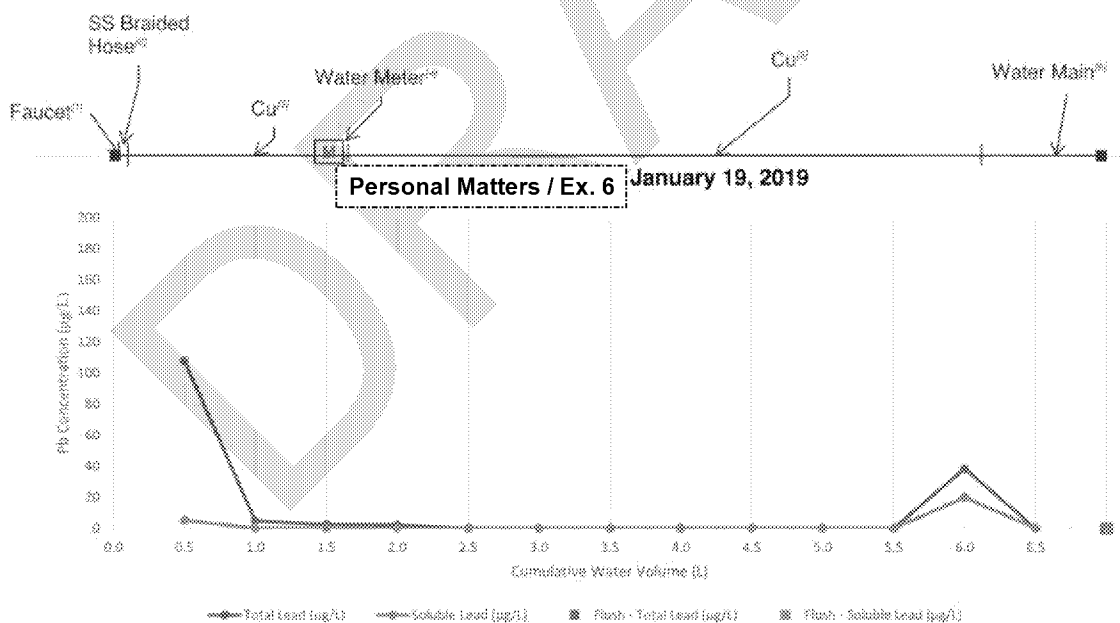
- After flushing the water at the faucet for 10 minutes, the soluble lead was non-detect (ND), and the total lead was 2.96 µg/L for the first sequential sampling. After the service line was replaced, both the soluble lead and total lead concentrations were ND in the flushed sample.

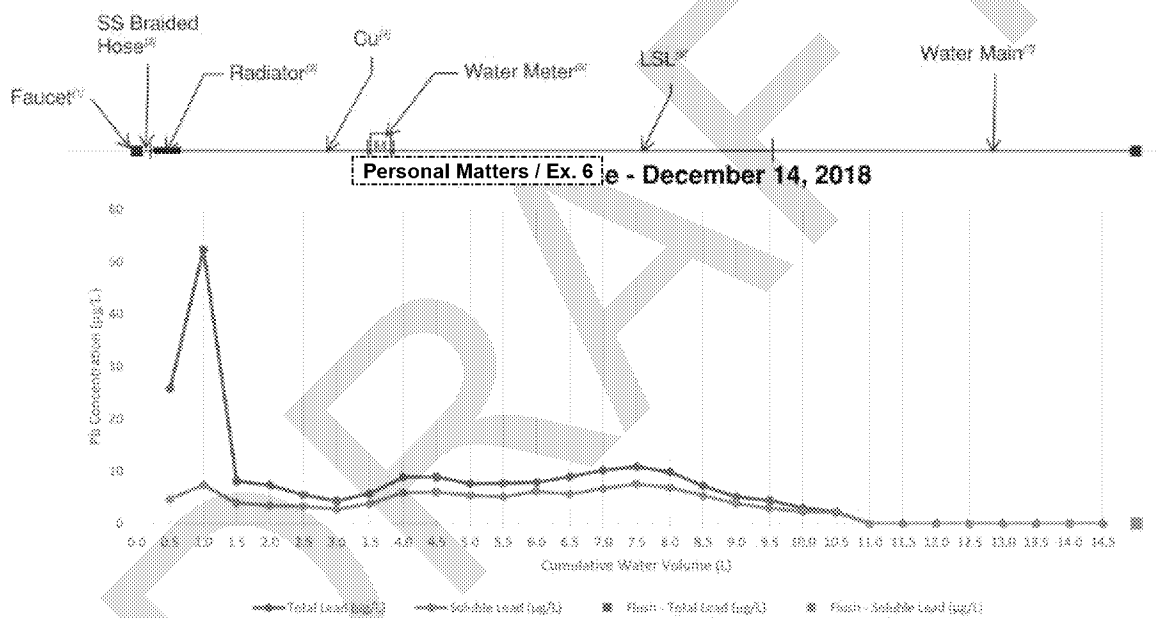
Figure 4-4 – Personal Matters / Ex. 6 Lead Profile – December 14, 2018

- The highest lead levels at this address were found in the interior plumbing components, including the faucet hosing and piping connected to the faucet. For the first sequential sampling, before the LSLR, the soluble lead peaked at 7.35 µg/L and total lead at 52.4 µg/L in the second sample (in the interior plumbing components after the faucet). For the second sequential sampling, after the LSLR, soluble lead peaked at 14.4 µg/L in the flushed sample and the total lead peaked at 17 µg/L in the fourth sample.

- Elevated amounts of particulate lead were found at this address the interior plumbing. For the first sequential sampling, the aerator was removed prior to collecting samples, but after flushing and stagnation. For the second sequential sampling, the aerator was removed prior to flushing and the stagnation period and remained off until sampling was completed. There was a slight increase in particulate lead right before reaching the water main and elevated amounts of dissolved lead in the flushed samples (samples 21, 24 and 30). The samples where the soluble lead is greater than the total lead is not plausible and will be re-tested and included in the update of this draft report.

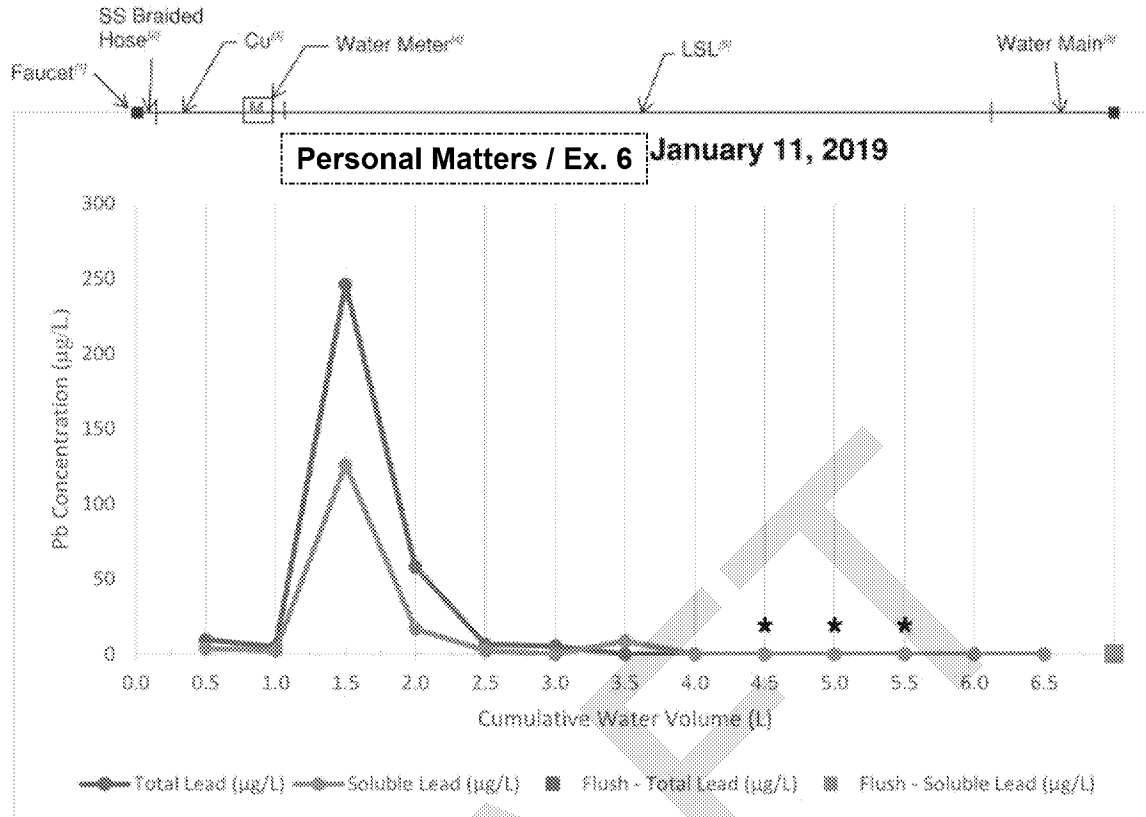
- Elevated particulate lead was found at this address in the third sample.
- Silica concentrations were an average of 3.64 mg/L as SiO<sub>2</sub>, which coincides with the Wanaque WQP ranges.
